NATIONAL TRANSPORTATION SAFETY BOARD

MATERIALS LABORATORY FACTUAL REPORT

Report No. 21-081

Place : Pine Grove, Oregon
Date : August 23, 2020
Vehicle : Kaman K-1200, N314
NTSB No. : WPR20LA283
Investigator : Fabian Salazar, ASI-WPR

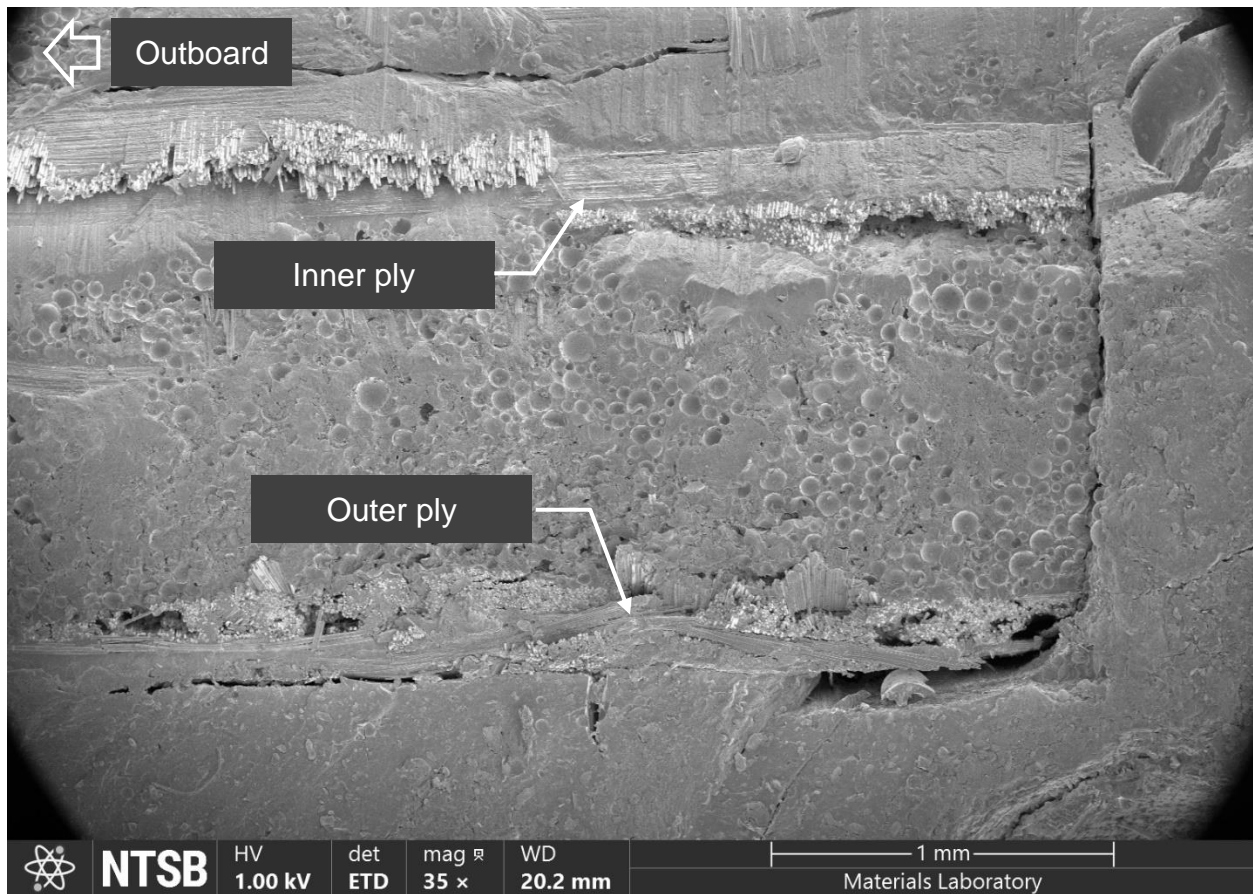
The spar / afterbody fracture was examined using a scanning electron microscope (SEM) with a focus on the fractured carbon fibers. Figure 27 shows an overview scan of the afterbody-side of the lower skin separation at the inboard end of the afterbody. Figures 28a – d show the afterbody and spar sides of the outer ply fracture at low and high magnification, respectively. On the spar side, the fiber fractures exhibited radial lines leading to chop marks (figure 28d) that were consistent with downward bending/buckling of the fibers. The fibers immediately adjacent to this region were also bent/buckled down. On the afterbody side (figure 28c), the fiber fractures closest to the interior of the flap exhibited radial lines consistent with tensile fractures, while closer to the outer (lower) surface, the corresponding fibers were not visible. As seen in figure 28b, the fracture plane in the region of buckled/bent fibers on the spar-side was offset from the adjacent fracture and most of the buckled/bent fiber fragments between the spar-side and afterbody-side fractures were missing. An additional cluster of buckled/bent fibers was located further outboard (figure 28a) and there were fiber fragments embedded in the fracture surface. Elsewhere along the spar / afterbody separation, fibers exhibited radial lines, consistent with tensile fractures, with occasional clusters of fibers exhibiting chop mark features, consistent with bend/buckle fractures. Fiber fragments and debris were often observed, consistent with fracture face contact. Several examples are shown in figures 29a – c. Along the lower skin and starting at approximately STA 2.00, most of the inner ply warp tows exhibited peel separation along their lower (outward) face (figures 30a and b). At approximately STA 28.5 the lower skin fracture shifted toward the leading edge by approximately 0.06 inch (figure 31) and the peel transitioned to transverse fractures across the inner ply tows (figures 32a and b) up to the outboard end of the flap.

Figure 27. SEM image of the servo flap afterbody fracture: afterbody side, lower surface, inboard end. The view is toward the trailing edge.

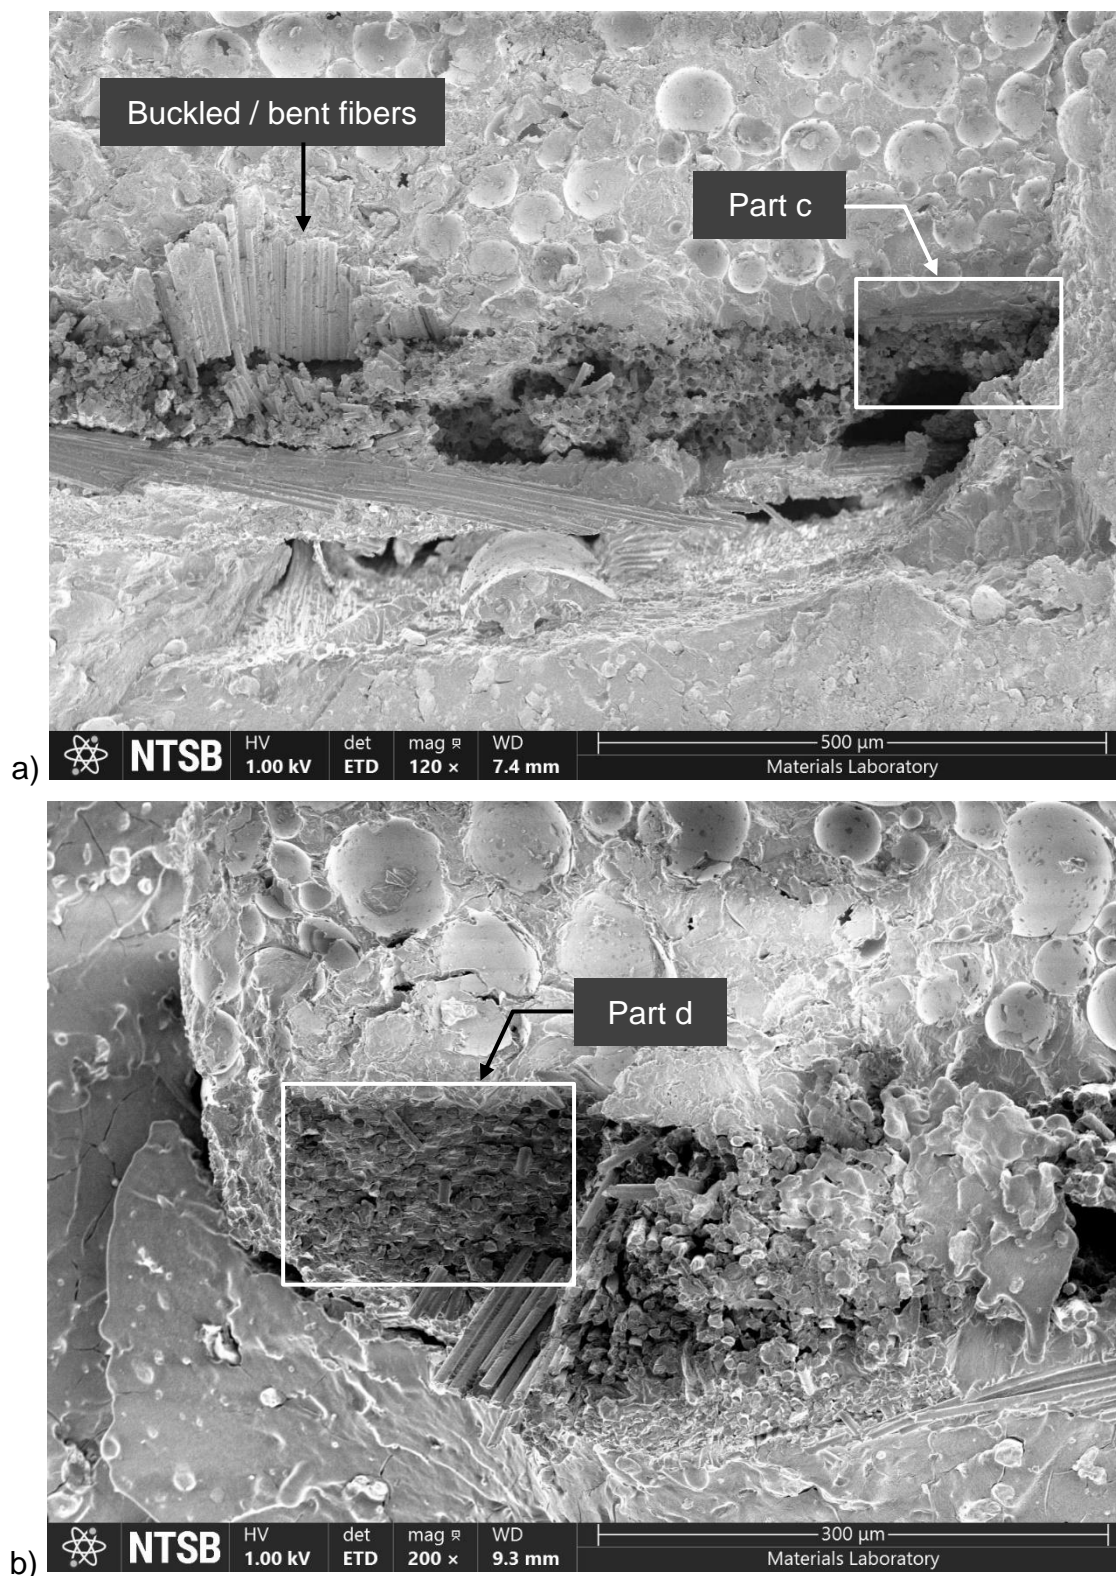
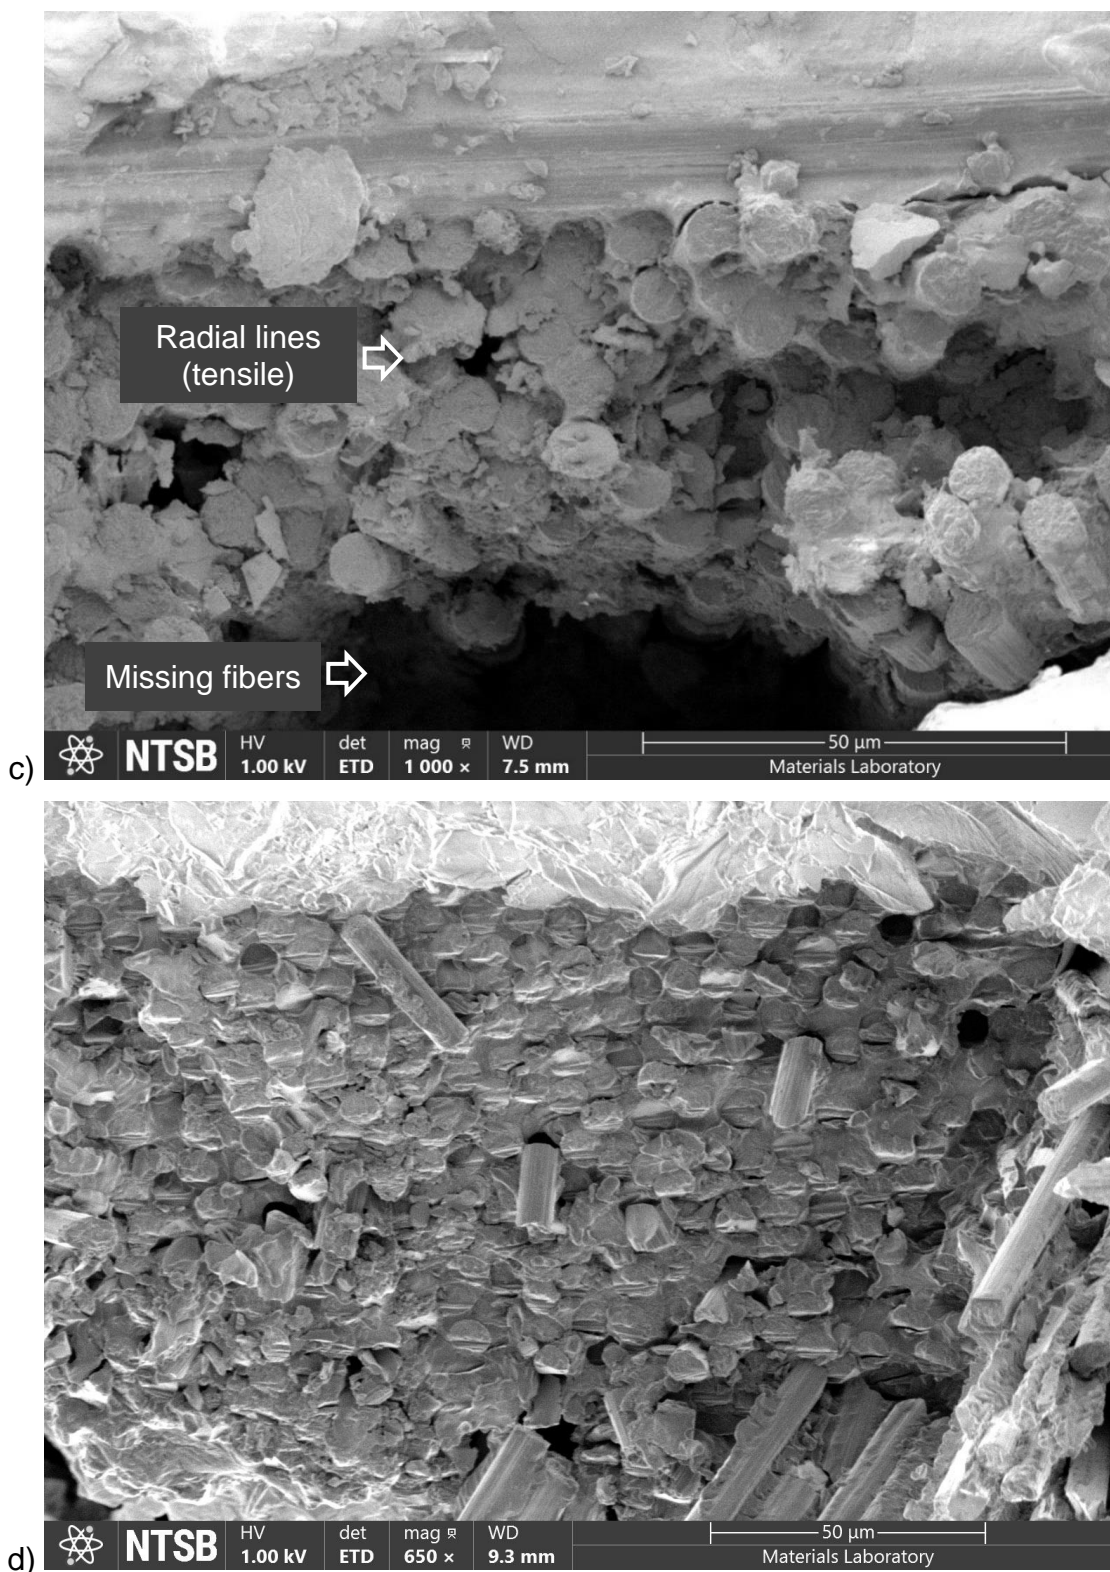
Figure 28. SEM images of the spar / afterbody fracture at the lower surface, inboard end, outer ply: a) afterbody-side of fracture; b) spar-side of fracture;

Figure 28 (cont.). c) higher magnification image from part a exhibiting tensile fracture and missing fibers; and d) higher magnification image from b with fibers exhibiting chop marks in a downward bending orientation.

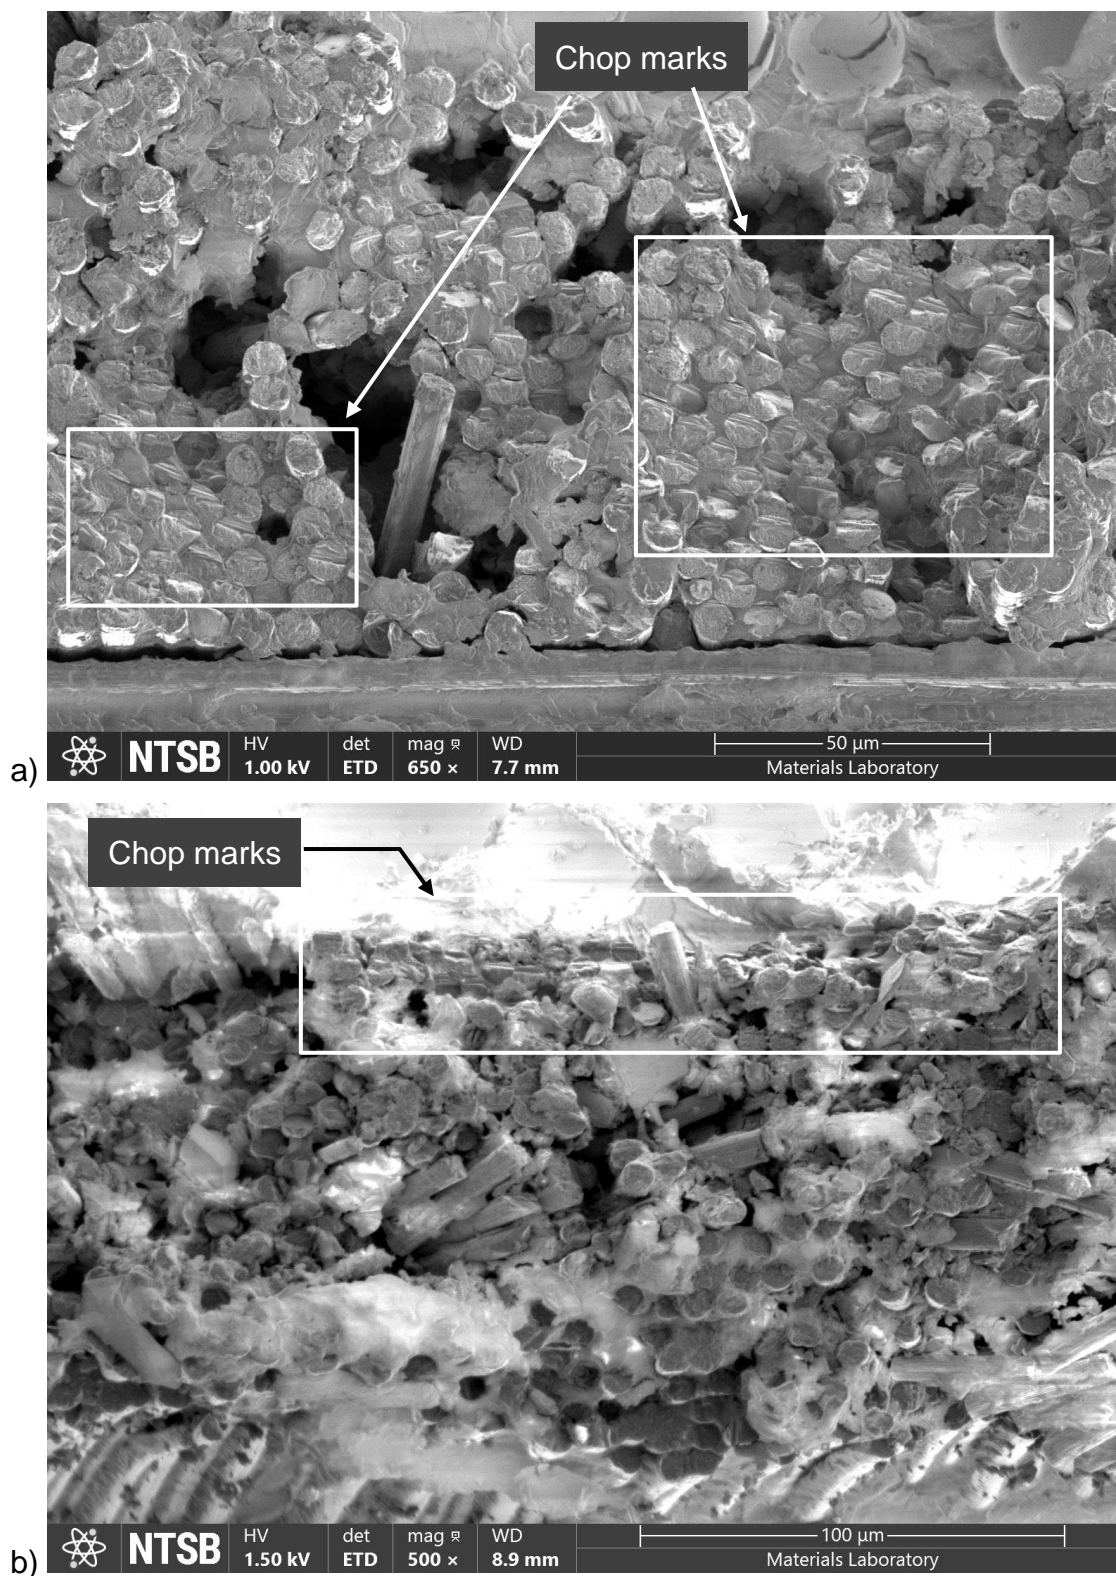
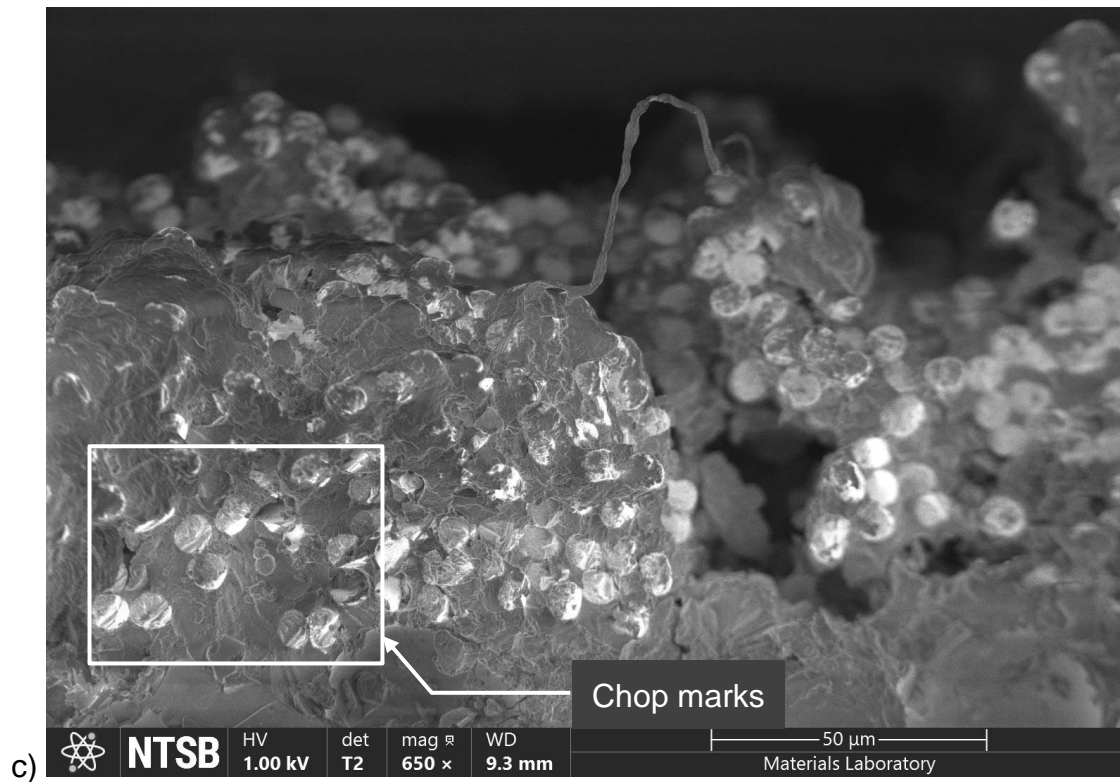
Figure 29. SEM images along skin plies showing chop marks, radial lines, fiber fragments, and debris: a) lower skin, outer ply, spar side, STA 2.00; b) lower skin, inner ply, afterbody-side, STA 6.00; and

Figure 29 (cont.). c) upper skin, outer ply, afterbody-side, STA 6.04, outboard of upper skin peel region.

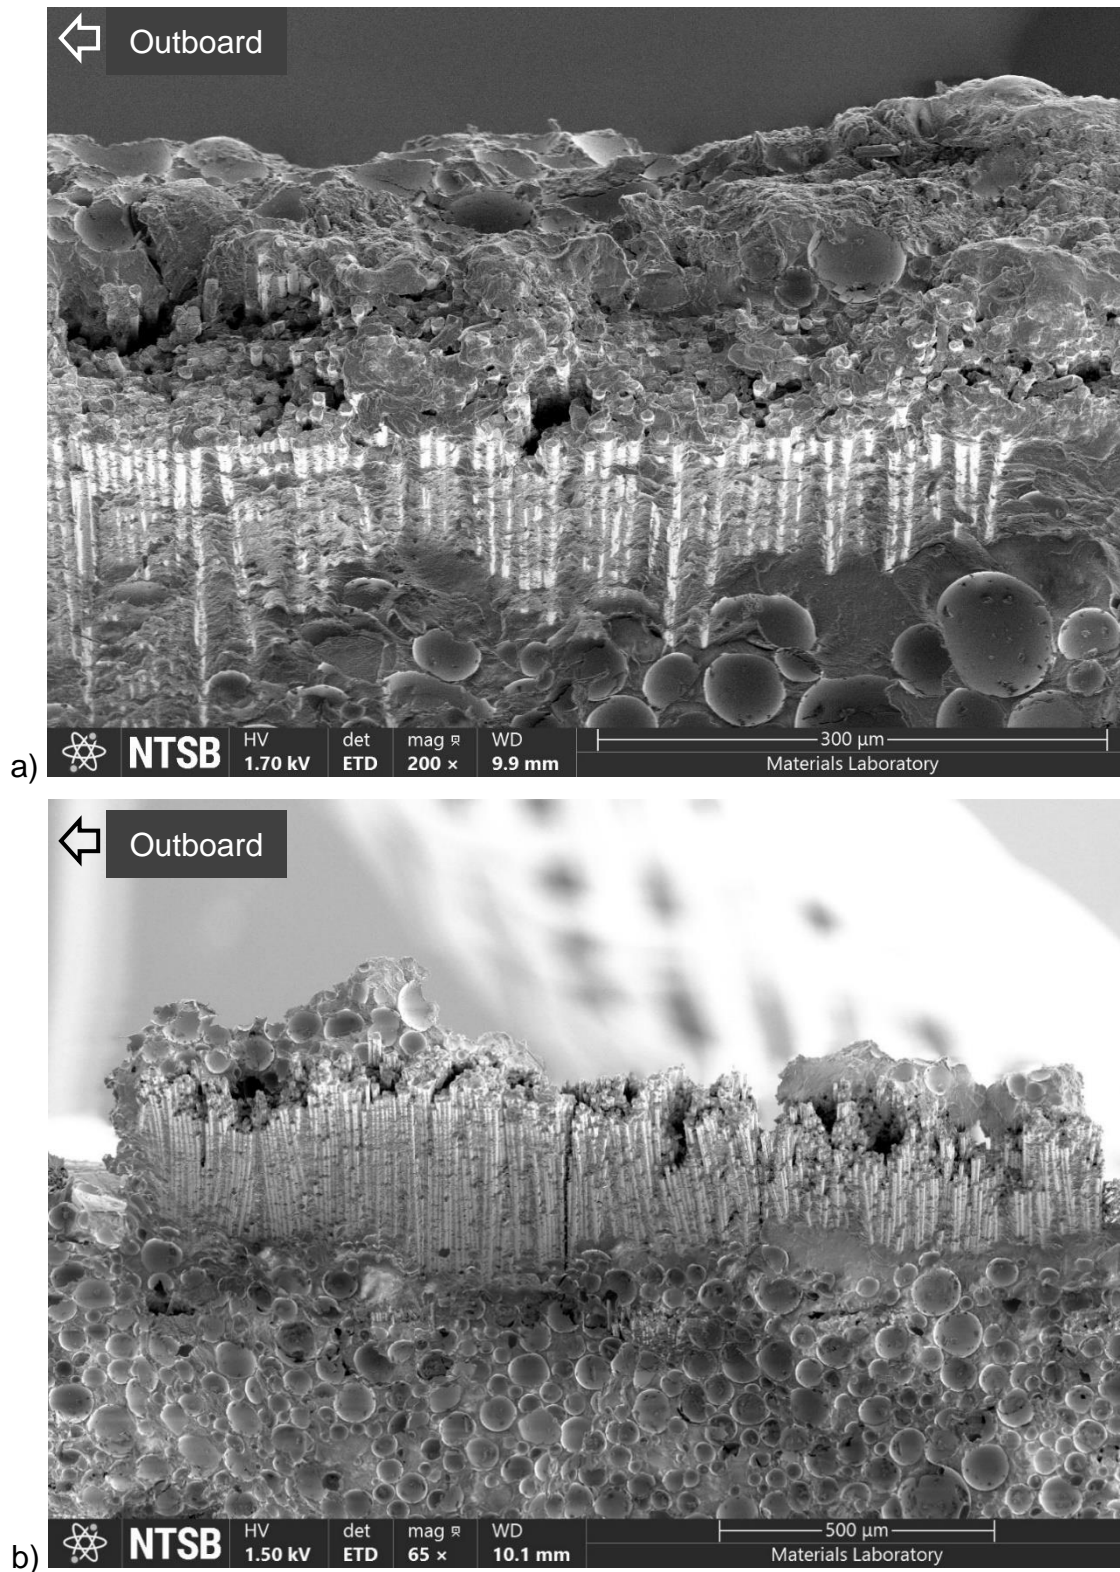
Figure 30. SEM images of fractured lower skin inner ply tows: a) peel along fiber tow at approximately STA 17.24 and b) peel along fiber tow at approximately STA 27.98.

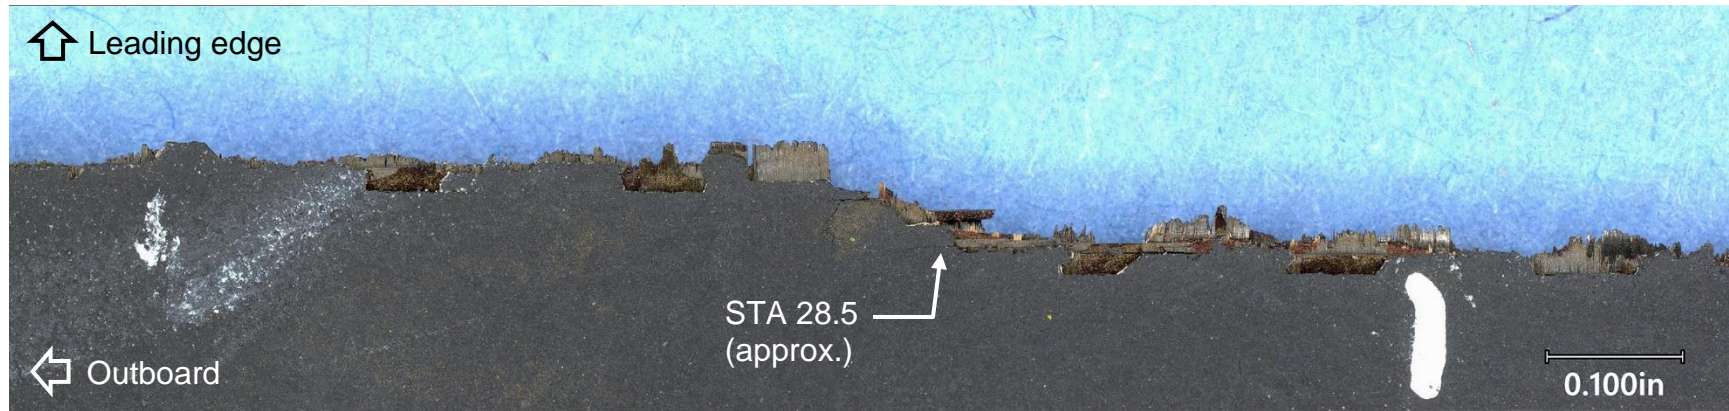
Figure 31. Image of servo flap lower afterbody skin showing chordwise (toward leading edge) shift in fracture path at approximately STA 28.5.

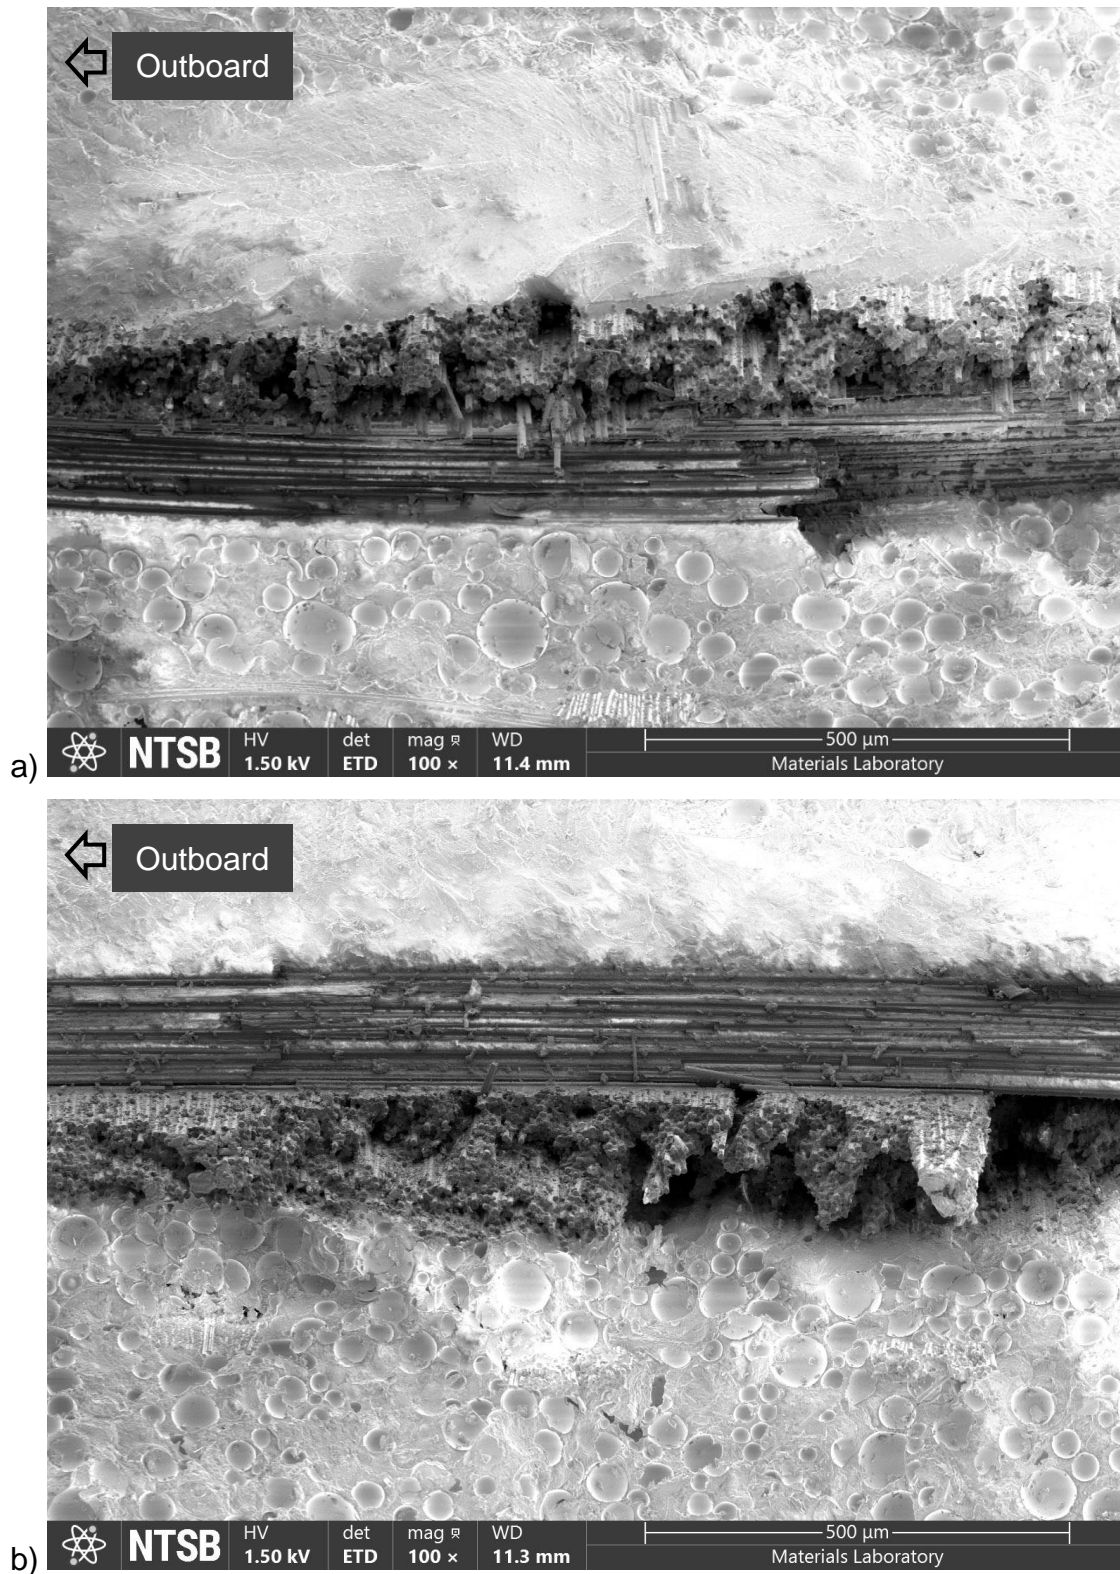
Figure 32. SEM images of fractured lower skin inner ply tows: a) transverse fracture at approximately STA 28.80 and b) transverse fracture at approximately STA 28.88.

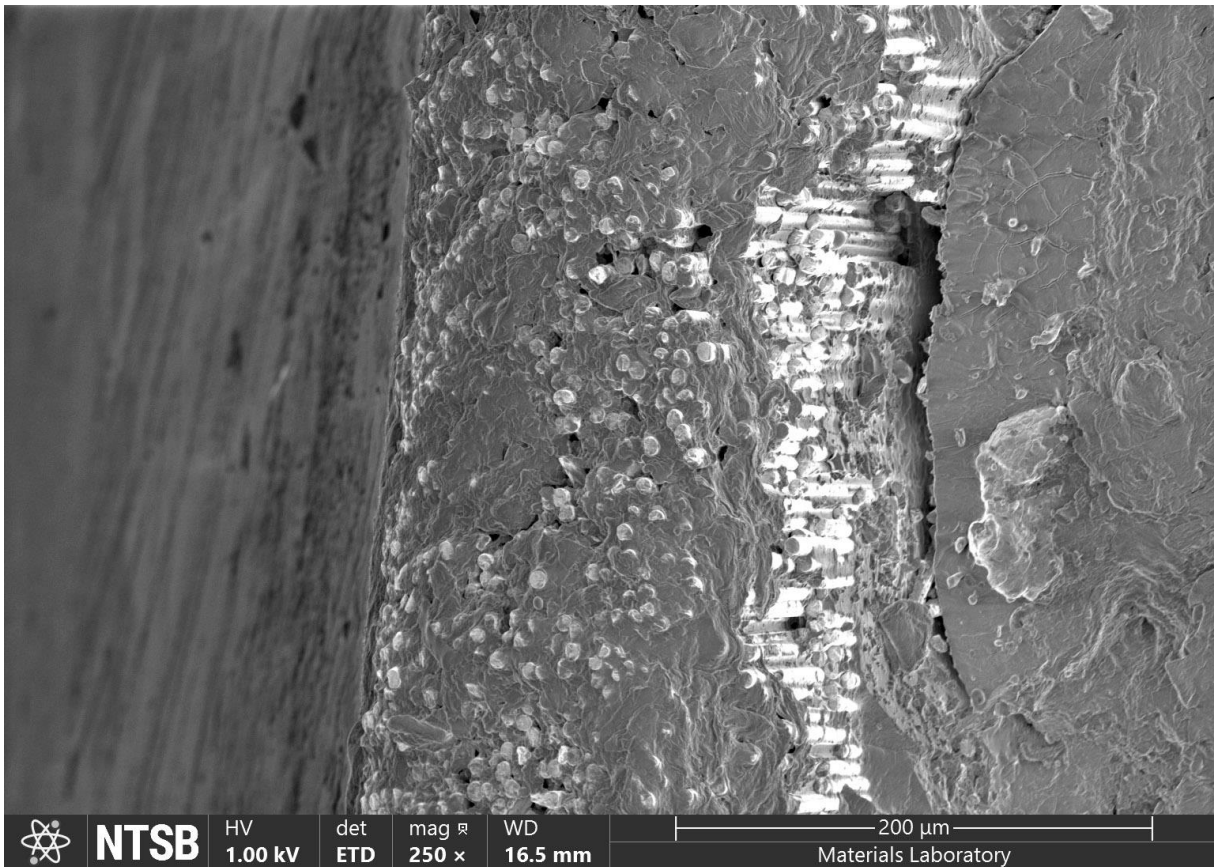
The missing bonding tab's separation from the inboard closeout was also examined by SEM as shown in figure 33. The fractured fibers exhibited rubbing and the surface was covered by debris.

Figure 33. Fractured carbon fiber ply where the bonding tab separated from the body of the inboard closeout, showing rubbing and debris.

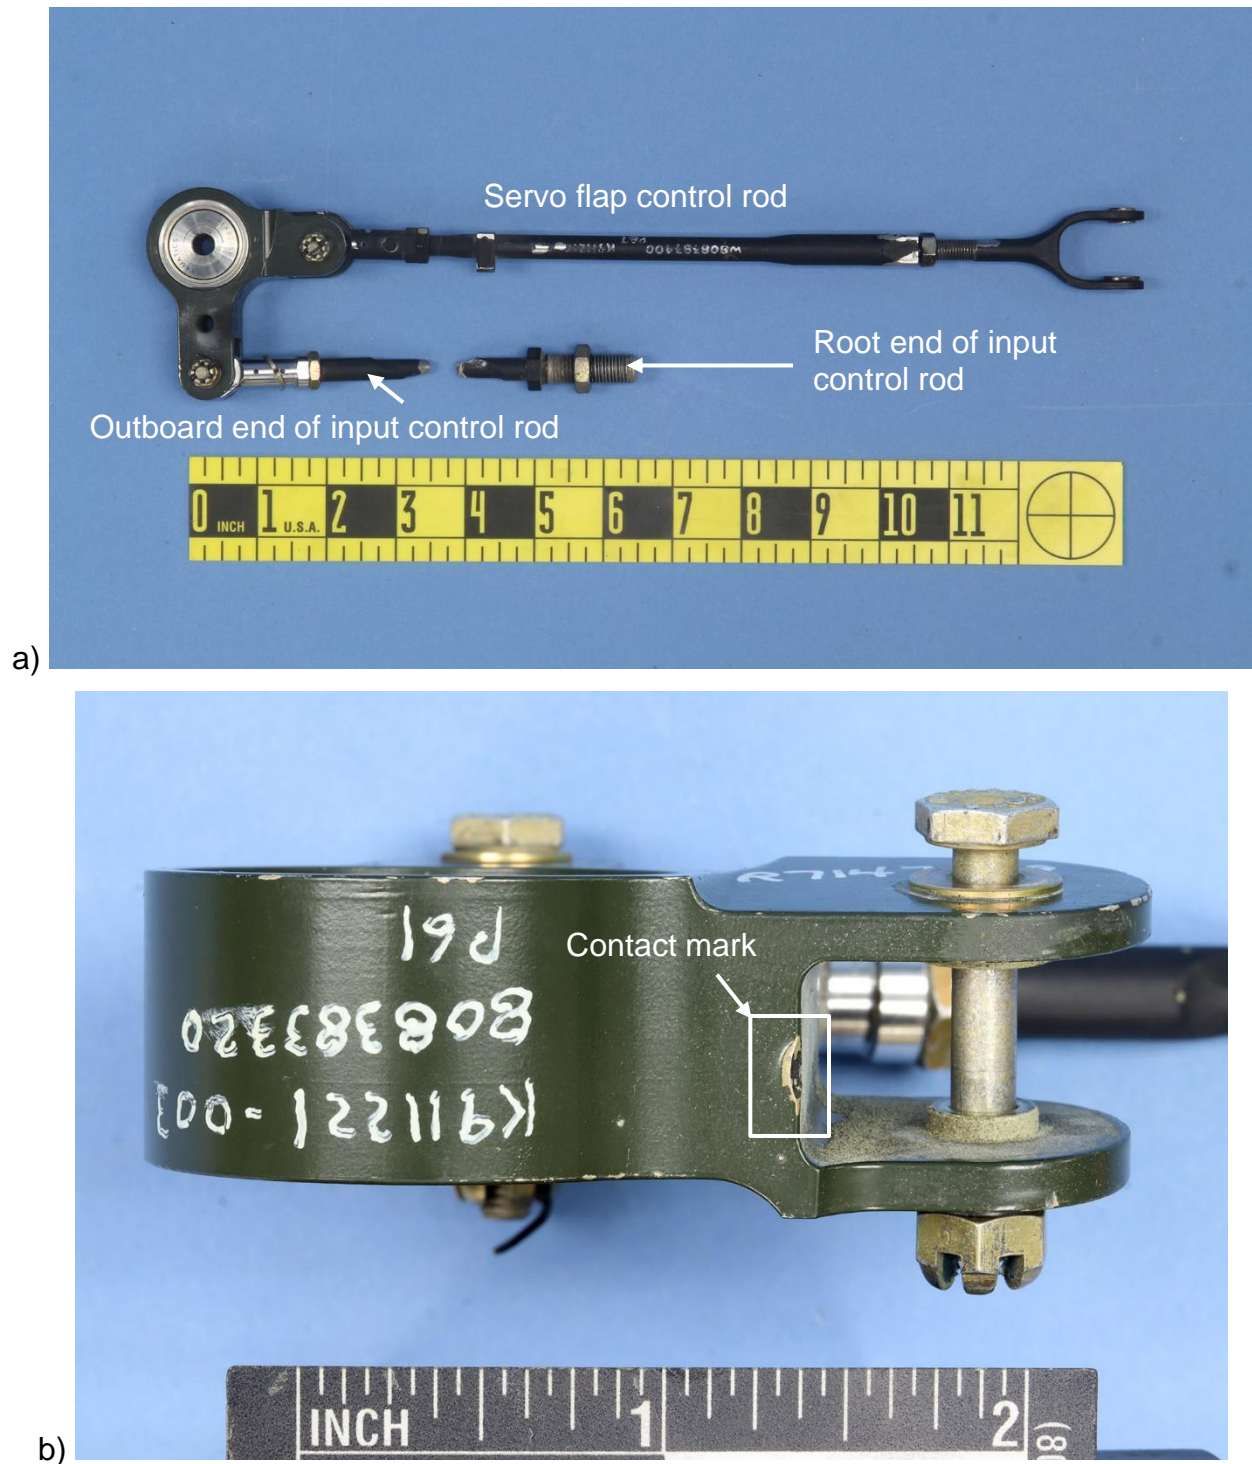
The servo flap pitch change control rod, bellcrank, and fractured ends of the input control rod (internal to the main rotor blade along the spanwise direction) are shown in figure 34a (shown in an arbitrary configuration). The input control rod was fractured near the inboard and outboard ends. The fractures exhibited necking and slanted fractures, consistent with overstress. The bellcrank exhibited a contact mark, indicated in figure 34b, consistent with contact by the rod end at the base of the servo flap control rod. Visual examination of the servo flap control rod indicated that the rod was bent, as shown in figure 35a. The other rods were removed from the aircraft and are shown in figures 35b – d.

Figure 34. a) LHW servo flap control rod, bellcrank, and fractured input control rod (located internal to MRB) and b) contact mark on bellcrank.

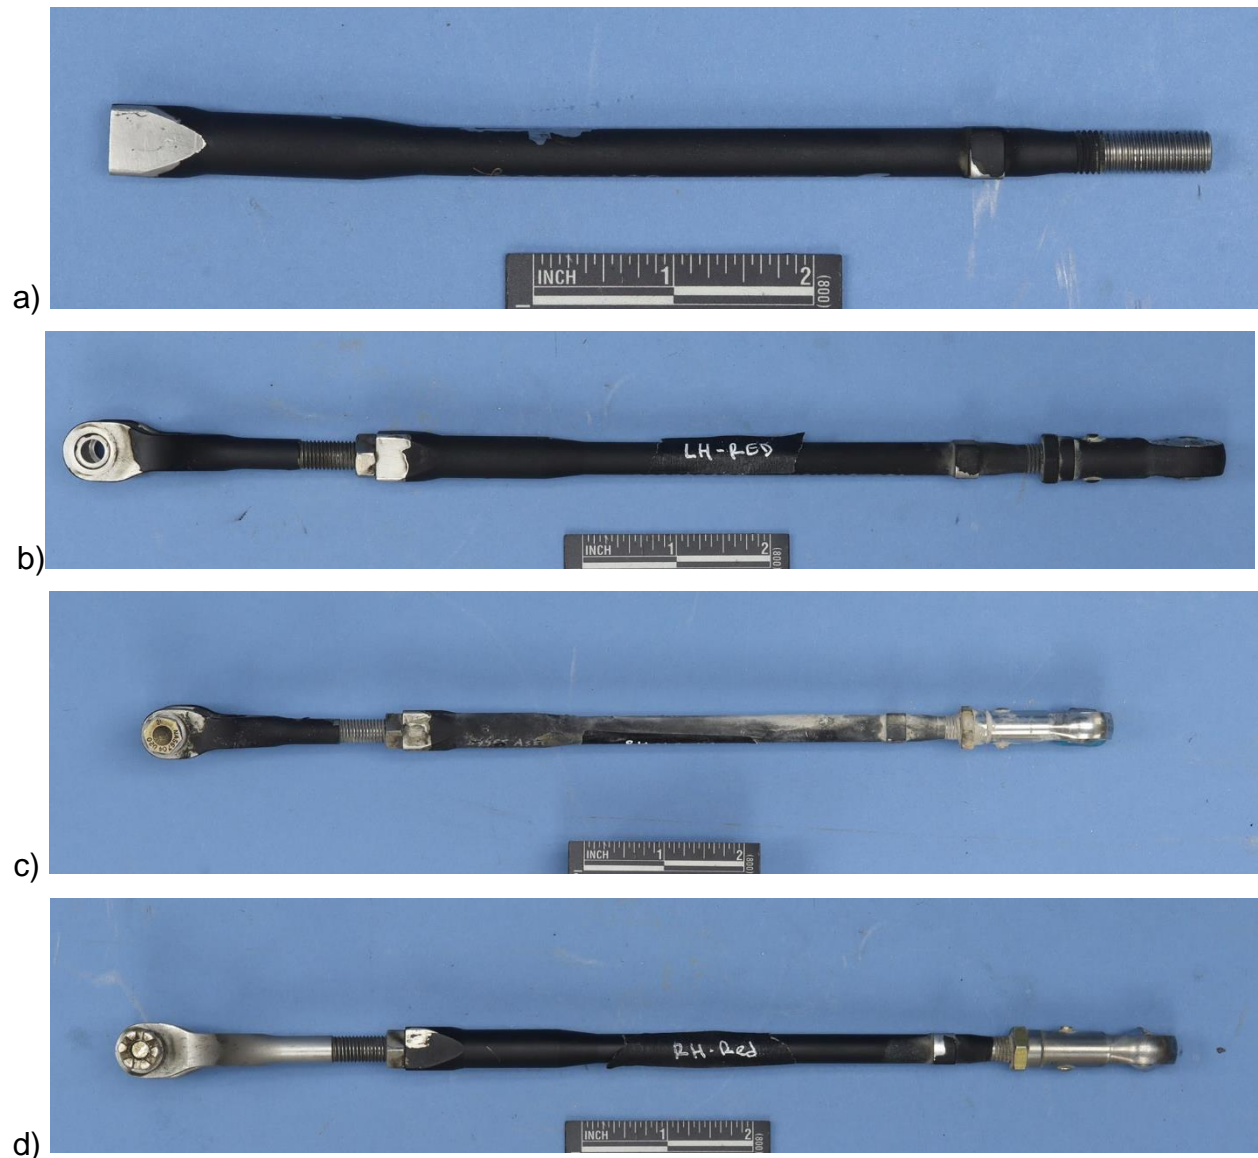
of each rod was measured with a Rockwell hardness tester in accordance with standard laboratory procedures. The results are shown in table 2. The bend angles for the control rods were 2.2°, 0.6°, 0.0°, and 0.1° for the LHW, LHR, RHW, and RHR flaps, respectively. The bend angles of the rod end clevises were 0.4°, 0.6°, 0.6°, and 0.6° for the LHW, LHR, RHW, and RHR flaps, respectively. The dimensional and hardness attributes met the manufacturer's requirements.

Figure 35. Servo flap control rods: a) LHW; b) LHR; c) RHW; and d) RHR.

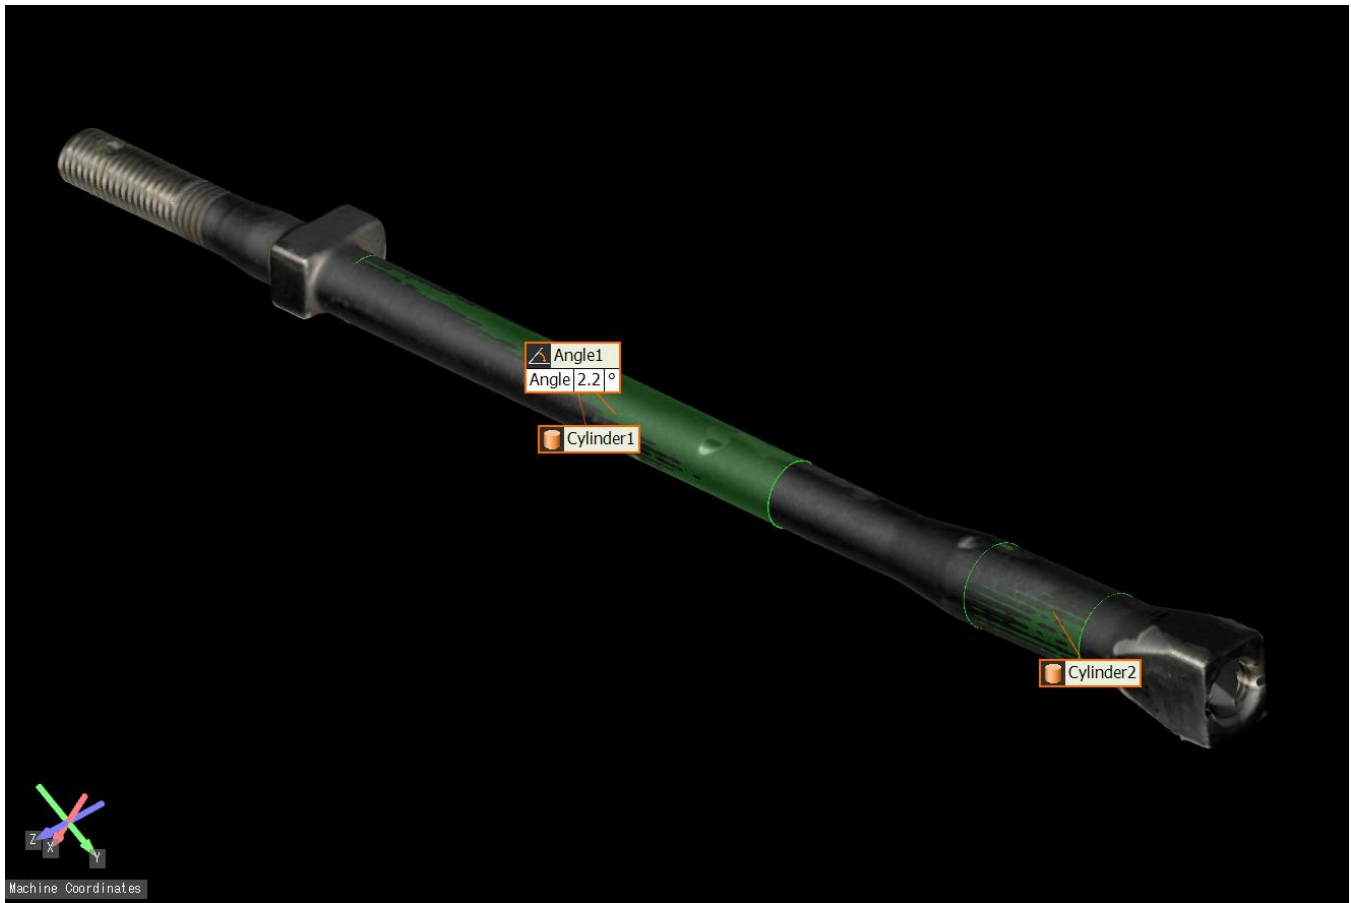
Figure 36. 3D structured light scan of LHW control rod. The image shows the objects used to measure the bend angle and the result.

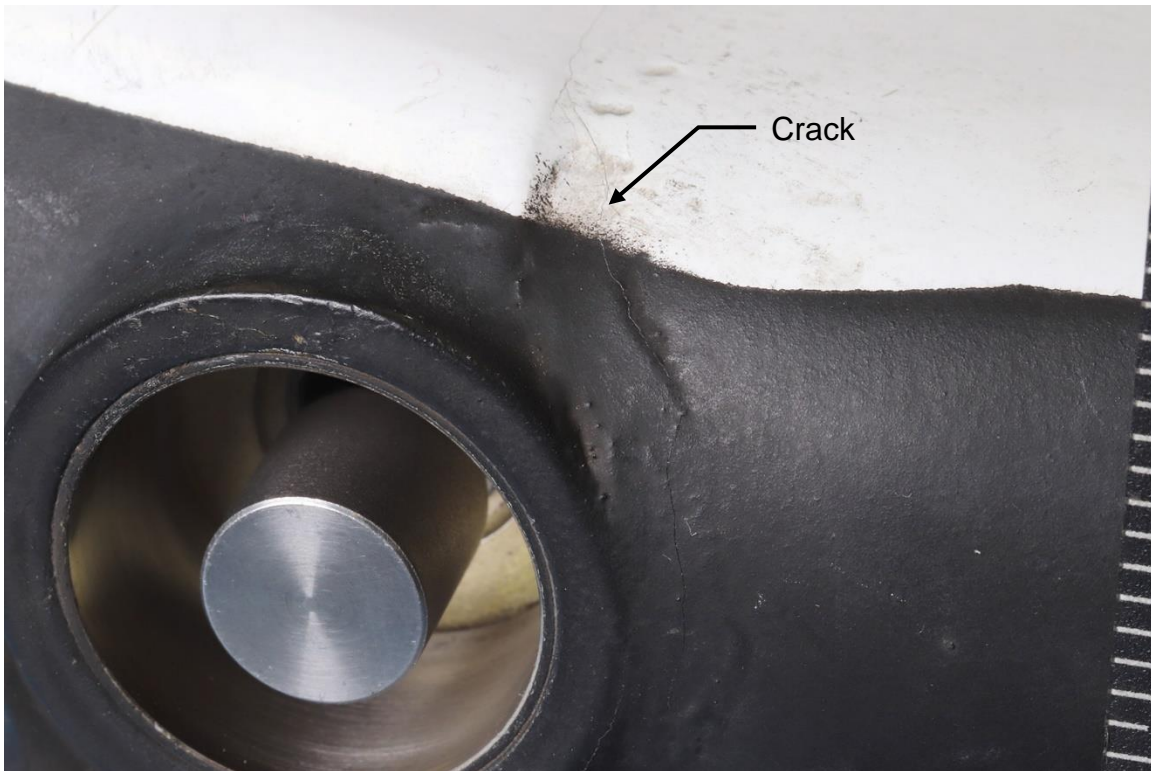
Figure 38. Hairline crack along upper side of inboard closeout on the LHR servo flap.

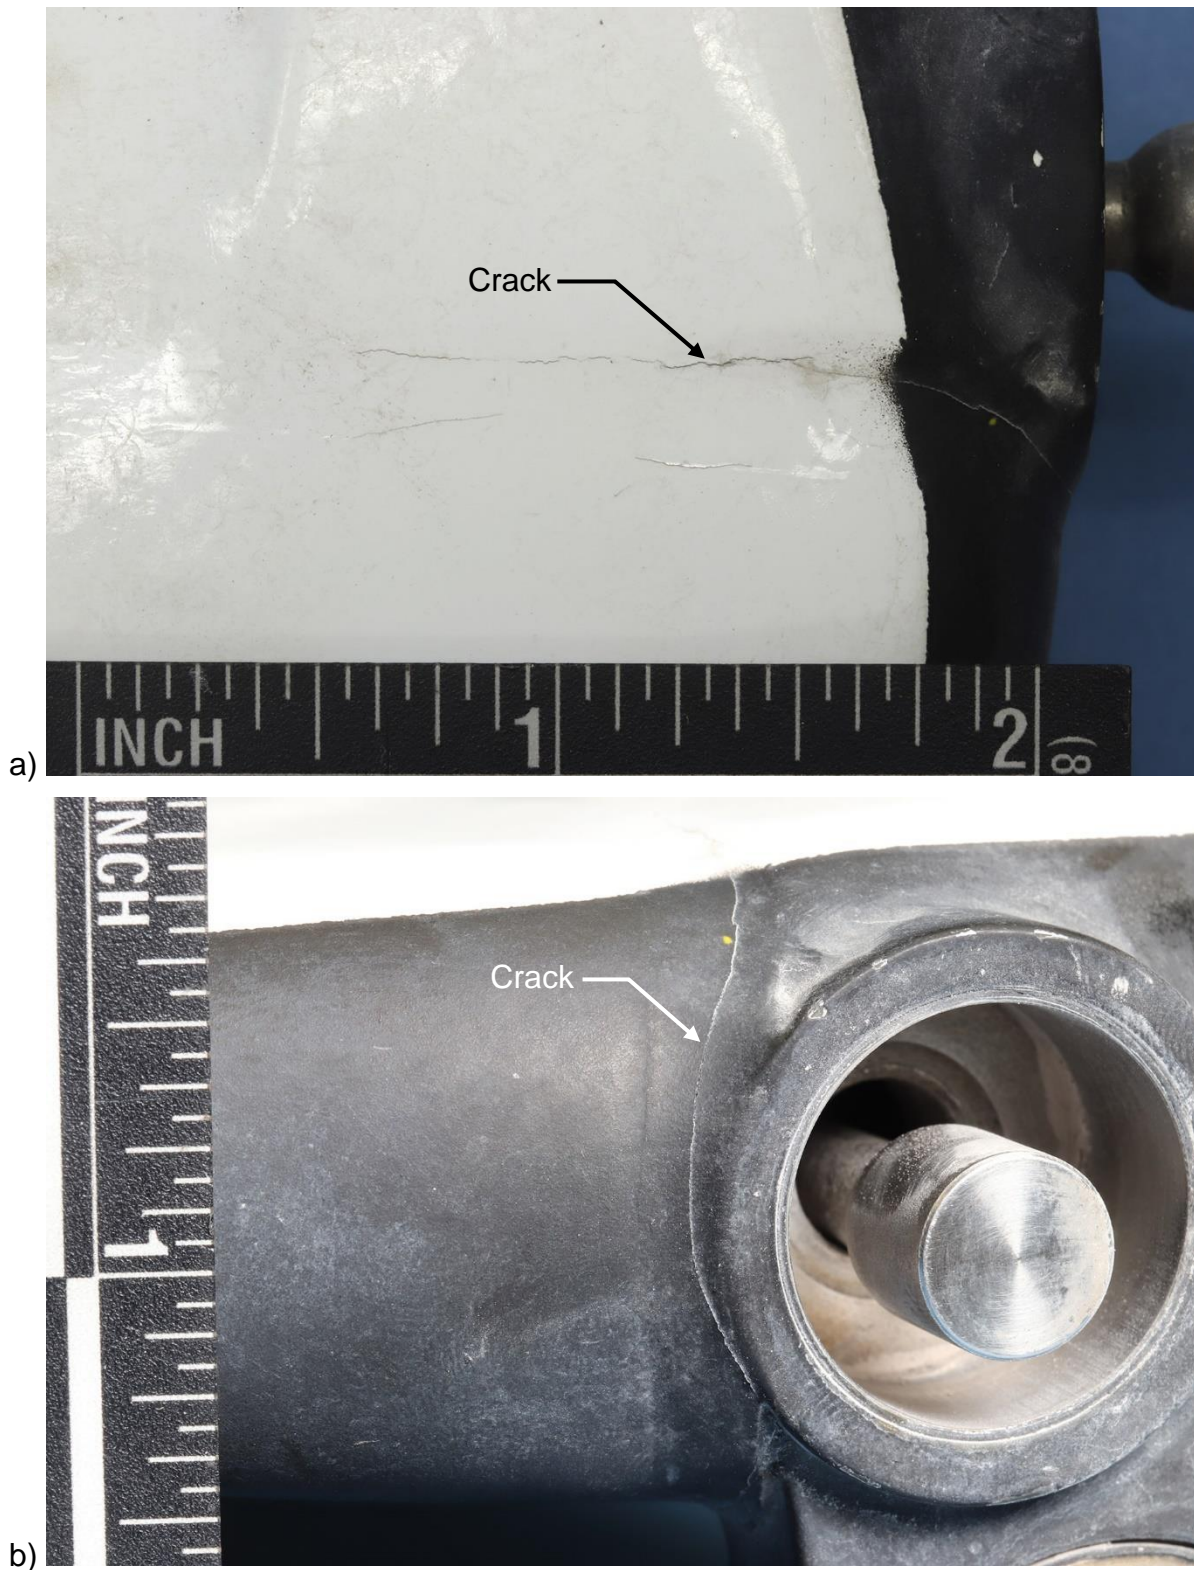
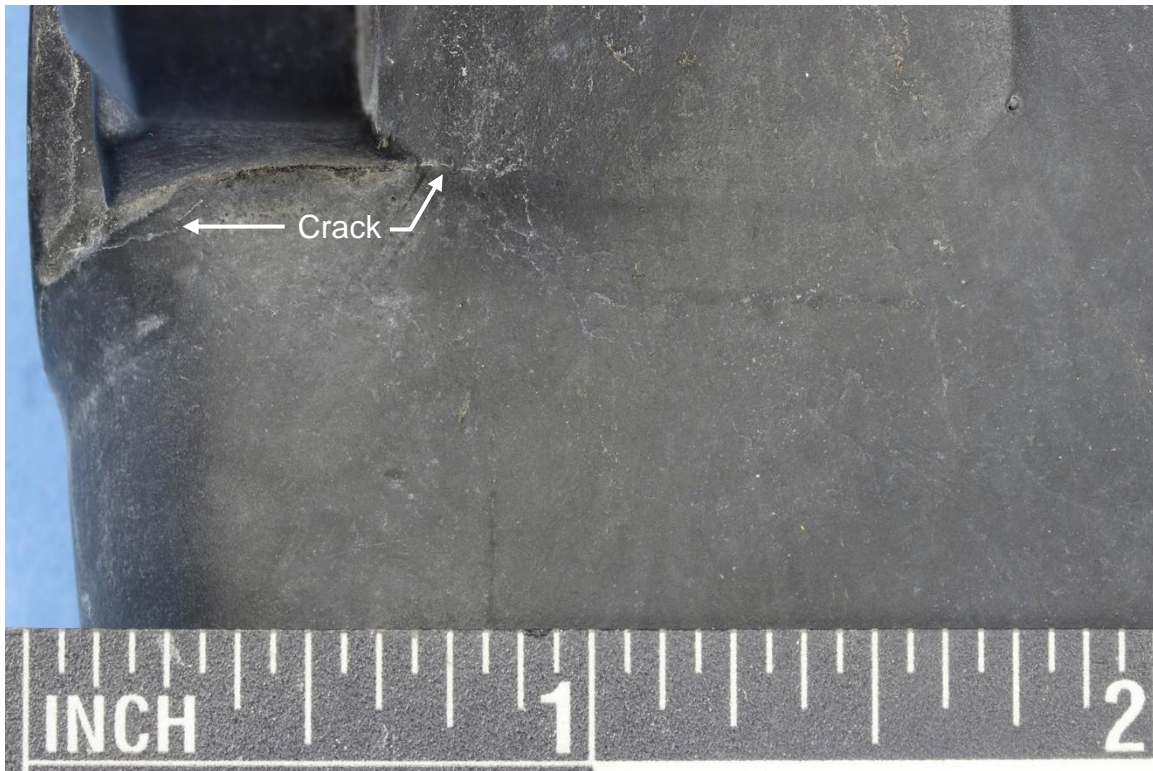
Figure 39. Images of cracks along edge of inboard closeout bond line on RHW servo flap: a) top side of closeout; b) inboard side of closeout; and

Figure 37 (cont.). c) lower side of closeout.
